SUMMARY OF SHOALING REPORTED FIRST COAST GUARD DISTRICT

Updated 04/06/2022

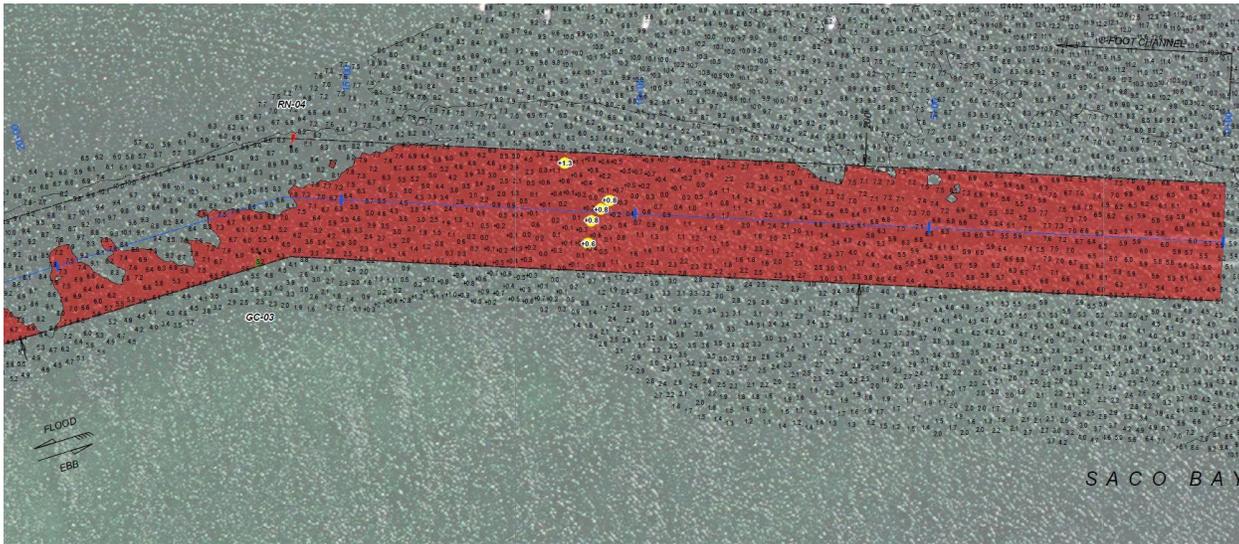
13286 13287 LNM 42/21

There is serious shoaling in the entrance to the Scarborough River in the vicinity of gated Buoys 1-2 and 3-4. Soundings of +0.8 at Mean Lower Low Water (MLLW) has been surveyed, that means the bottom is exposed at the lowest possible tide. Mariners are advised to use caution when transiting the Scarborough River and do so only at higher tides.
